ANNEX 1 ► Site Descriptions (access A-U) and Management Recommendations

ACCESS A – U

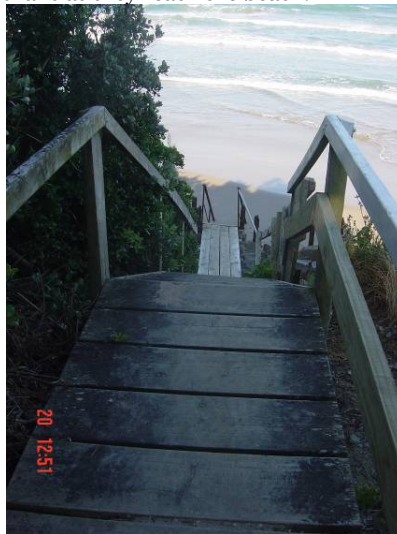
The southern-most access to Wainui Beach is clearly visible from the road, with carparking leading onto a well-maintained path. The fence is white and needs replacing with organic materials (i.e. not painted white). The fence provides good push-chair access and a rubbish bin in good condition is in a suitable location. A sign advising dog owners of by-law regulations is also found at this site. A unified small sign is recommended at the site. While the vegetation is similarly well-maintained, it is predominantly plant pests such as Chilean rhubarb and agapanthus complemented with many garden escapes. The stairs onto the beach are the main development priority at this site as they currently rusted metal handrails as they reach the beach.

Figure 9: Access A (Tuahine Crescent) stairs.

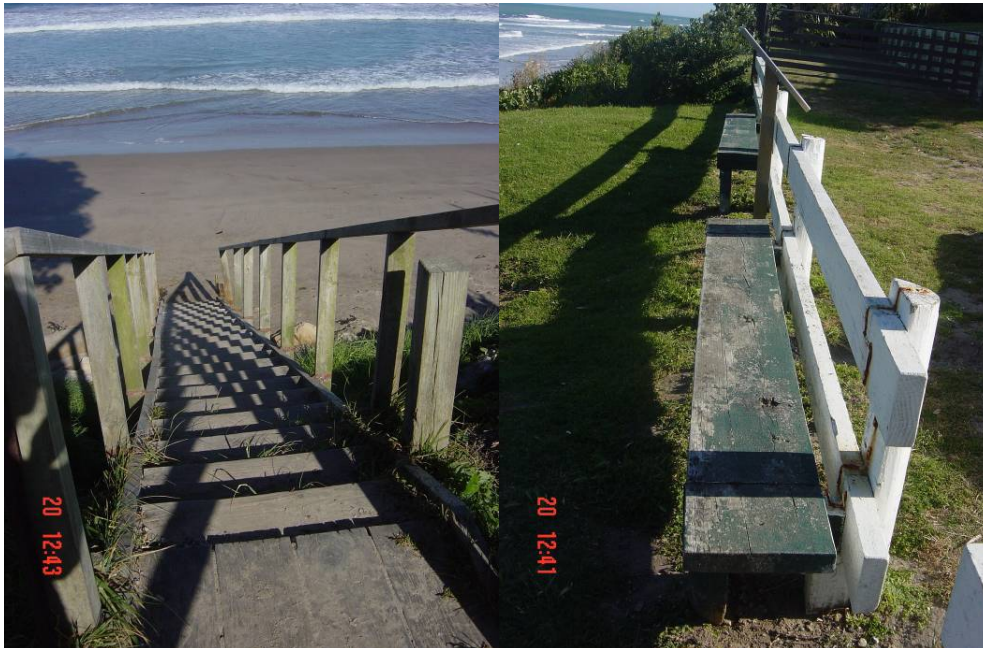
This beach access also features a white fence, a set of stairs in fairly condition and a rubbish bin. It also has a Weedbusters sign placed in the middle of the site, on the fence, which has a long low bench seat in fair condition on either side of the sign. The seats are on the beach-side of the fence. This site has a steep embankment infested in plant pests which should be replaced with stabilizing indigenous vegetation.

Stairs and fenced access to Wainui Beach from Access B

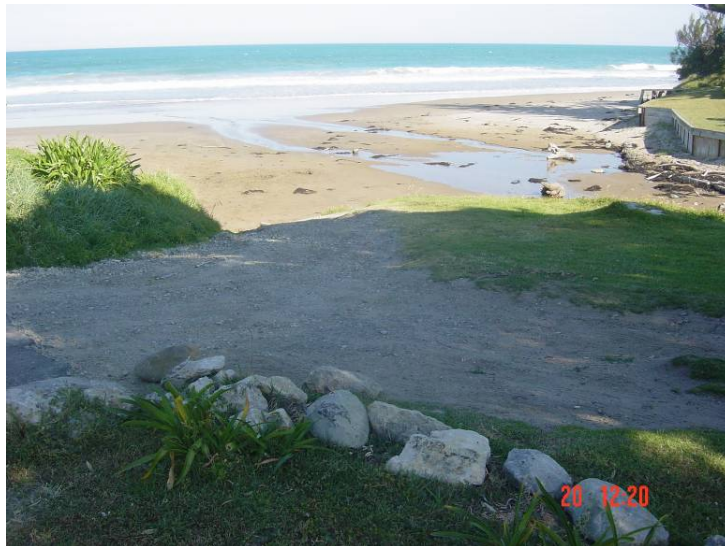
As the stream track meets the end of Pare Street, a sign is erected advising the public that: 'Vehicles are not permitted to drive along the beach except for boat access by Order GDC'. The sign is in good condition. The boat-ramp is not in such condition, particularly on the metal road surface. This surface needs upgrading²³. The boat ramp area looks generally untidy and it is recommended a proper turn-around area is developed. Plant pest removal and indigenous planting along the riverbank and primary dune area, leading into a dune-care programme, would enhance this location.

Figure 11: Pare Street road end and boat ramp.

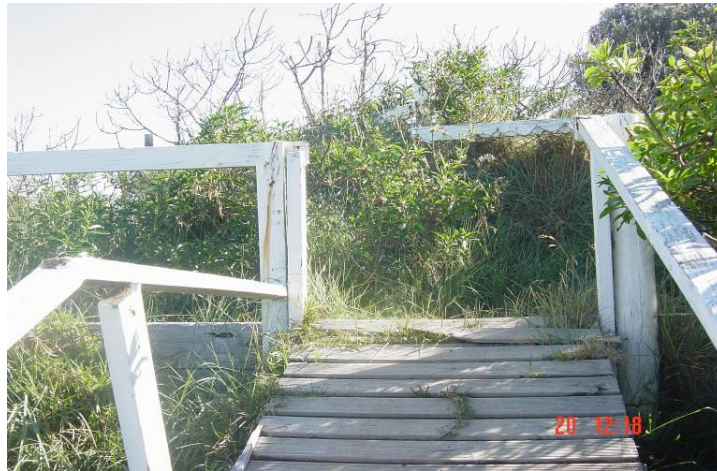
The entrance to Cooper Street should be updated and the rubbish bin should be upgraded. The carpark on the roadside should be demarcated to show parking for three cars. While the track and steps are in good condition, the fencing rails along the length of the track could be upgraded. The path forks to the left before it reaches the wooden steps and wooden ramp down the beach. Firstly, this ramp and the associated railings are in urgent need of upgrading. The ramp is rotten, the gradient is so steep it is difficult to walk up it, and it is very uncomfortable under-foot. See Figure 12 below:

Figure 12: Steep ramp with broken railings showing rot at the top.

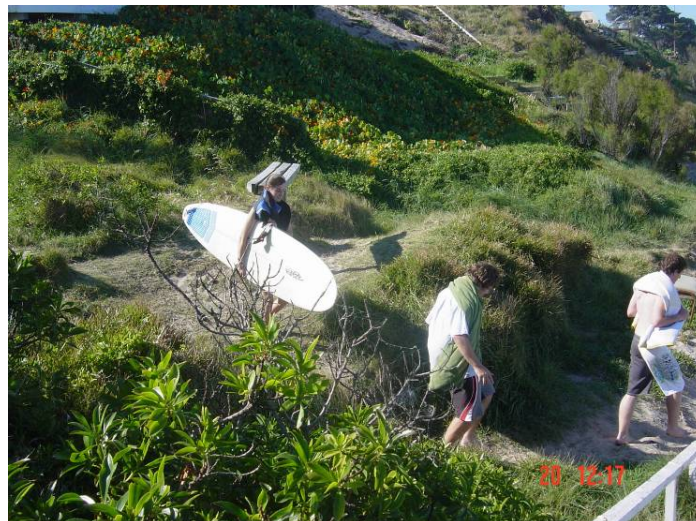
Due to the condition of the ramp, users are choosing to take a fork to the left of the track, just before the wooden ramp begins. The fork leads across a wooden footbridge (also rotten in places), to a flat grass area. At the flat grass area a single bench-seat is located that is too high to sit on. The bench-seat needs to be moved a metre back from the dune-front and the height adjusted to make it comfortable to sit on. The area around the seat should be demarcated so it is clear that people can sit and watch the surf here, but not walk out across the dunes. The main problem with users taking this fork in the path is that it is exacerbating erosion along the primary dune-face. Users have worn at least three tracks through the dunes and erosion is present. It is recommended the wooden ramp is replaced with a solid comfortable structure and the dune-care programme is extended along this dune-face, together with demarcating the seating area, to stop people using the dunes to access the beach.

Figure 13: Surfers using the dune face as beach access at Access E.

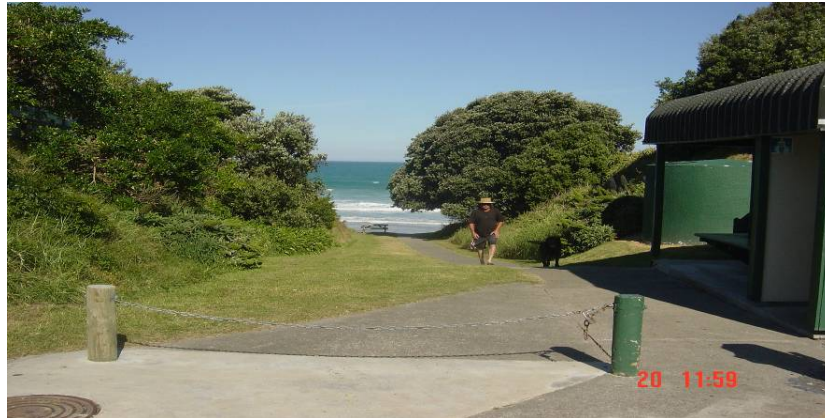
The well-used access commonly known as Stockroute is overall in good condition. There is a rubbish bin, bollards and chain, and a public toilet and changing room facility at the entrance. There is plenty of off-street parking, the path is in good condition and the stairs have been recently upgraded²⁴. There is one picnic table located in a good position to view the surf. The access is light and open with vegetation on both the southern and northern boundary slopes. The vegetation is mainly garden escapes and plant pests such as wild ginger which require replacement with appropriate indigenous species such as flaxes, cabbage trees and other secondary dune species. Several mature Pohutakawa trees make this access a pleasant place to watch the surf or eat an ice-cream during the summer.

Figure 14: Stockroute from the carpark

Staff recommend moving the existing table to the southern side of the path and creating a ponding area to collect stormwater. The ponding area should be planted in indigenous wetland plant species. Wide shallow steps should be developed to provide access to the beach, as well as to provide a gradual stormwater run off to the beach.

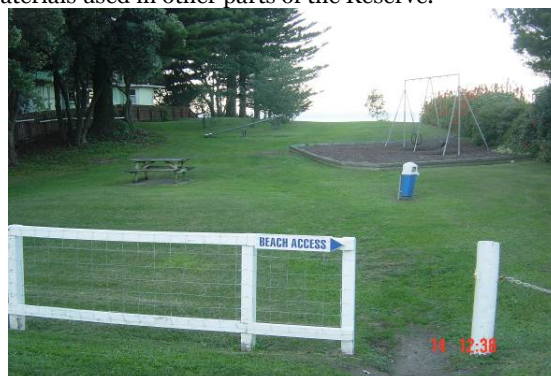
Figure 15: Access G

This site offers beach access, children's playground facilities (2 swings and a seesaw), a picnic table and rubbish bin. The sign needs upgrading, the stairs are not in good condition and the picnic table and rubbish bin need upgrading. Plant pests should be removed and any landscaping/planting should be done with indigenous plants. Overall, the area should be kept as an open space. Perimeter fencing along the road-front should be upgraded and constructed of organic materials consistent with materials used in other parts of the Reserve.

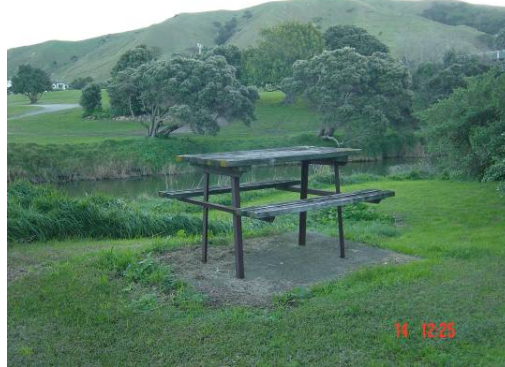
There is a new rubbish bin placed near the table with ocean-views and on the edge of the carpark. Softscaping with indigenous wetland species, such as flax along the riparian margin, removing the 'rockery' landscape, and removing the plant pests around the perimeter of the site, will significantly improve this area. The 'rockery' could also be removed and replanted with a Pohutakawa tree.

Figure 18: Table and plant pests along the Hamanatua Stream bank at Access J.

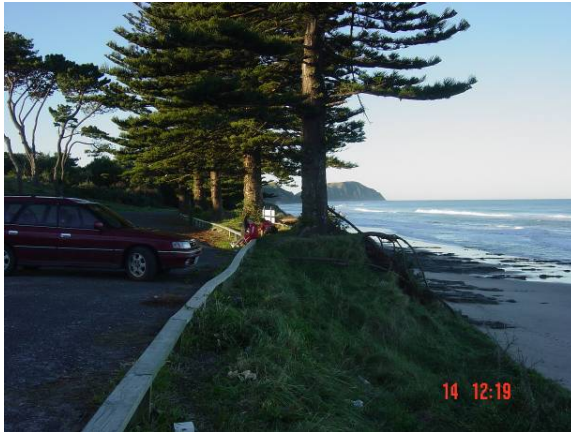
Pines carpark and bank showing erosion and plant pests

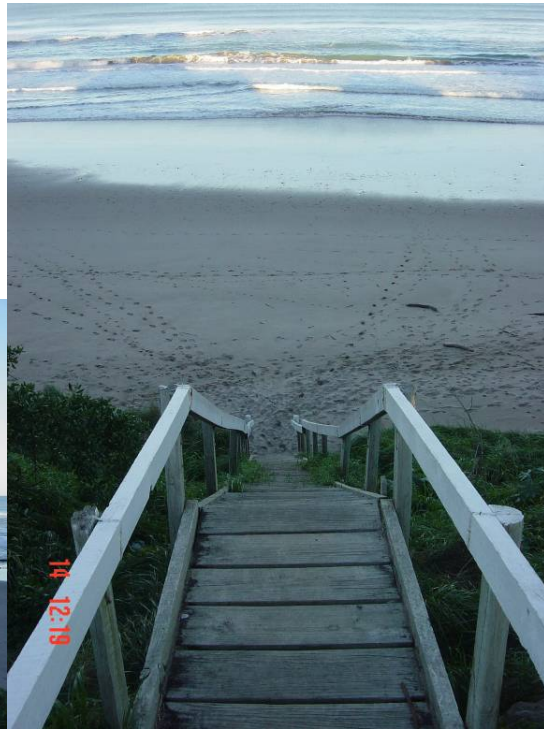
Southern set of stairs at Pines

There are also two stairs for pedestrian access to the beach. The southern-most, and most-used stairs, are in poor condition and need replacing (stairs above). The northern-most set of stairs was replaced in 2006. There is a sign about weeds and pests at the top of these stairs, as well as another sign informing the public about weeds, by one of the rubbish bins. To the left of the stairs is a sign denoting the area as 'The Pines'. This sign could also be upgraded in organic materials (wood).

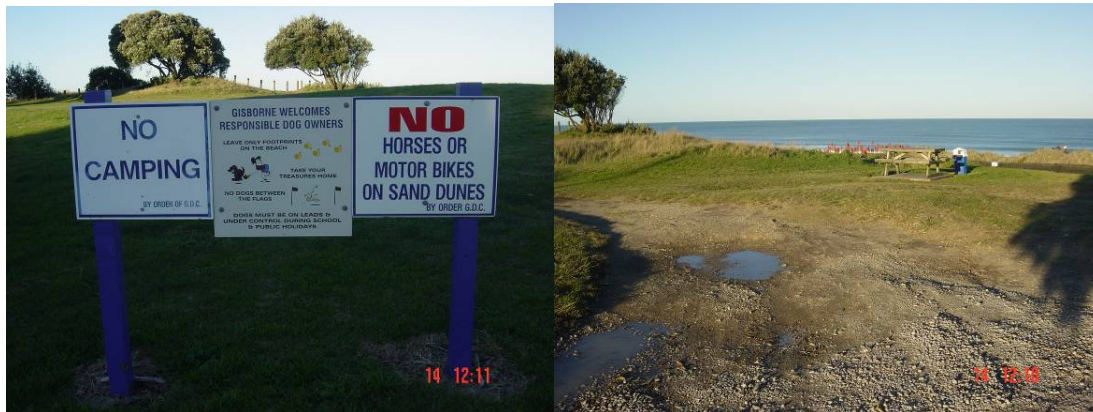
Located at Car Access M are one picnic table in the middle of the site, a rubbish bin at the road entrance, a plethora of small signs and another picnic table and rubbish bin closer to the dune edge. Natural wood bollards fringe the northern perimeter, however, vehicles are driving/turning around on the extended flat grass areas. These bollards should be removed, and instead, the carpark and road surface should be upgraded with a hard-wearing porous surface and perimeter fencing placed around a defined carpark area.

Northern bollards, signs and damage to secondary dunes
Due to vehicles during the winter months at Access M

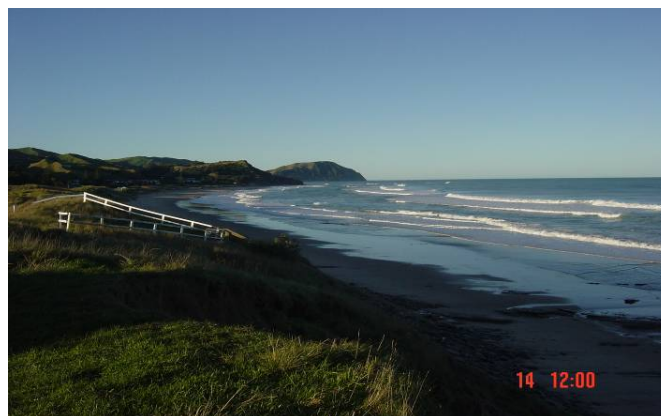
This site provides access to a popular surfing location. The car park requires demarcation with perimeter fencing and a hard-wearing porous surface for the road. The white fences should then be removed. A picnic table and rubbish bin should be placed to maximise the view. The most significant management issue at this site is duneface erosion directly in front of the access from the road. After walking or driving down the access road, people are walking straight over the duneface. This action has caused significant slumping. The reason this is occurring appears to be due to the fact that the stairs at this location, while in good condition, are located further north of the first carpark area. With the state of the 'road' deteriorating, only 4 wheel drive vehicles would be able to drive over to the park closer to the stairs. It is strongly recommended that the road surface is improved and the carpark space is moved further north, closer to the steps. This will also serve to screen the carpark from the State Highway. A clear path/sand ladder should lead from the northern tip of the newly designated carpark, over to the stairs. A temporary fence could be placed across the area where slumping has occurred. If after monitoring the impact of the designated walkway it appears people are still walking over the duneface, it may be necessary to place stairs directly in front of the carpark.

Figure 22: Northern set of stairs at Access N, from the current carpark area.

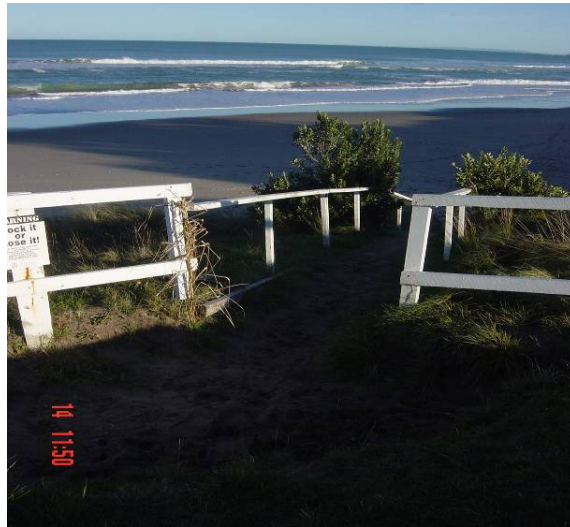
At each end of the white fencing which protects the dunes, are stairs offering pedestrian access to the beach. One set of stairs (southern-most) should be built to enable members of the public with mobility issues, including mothers with prams, safe access. The fencing and stairs are all in need of replacement and should be constructed of organic (wood) materials (i.e. not painted a colour). This fence should be kept at its current height to ensure the public is not tempted to walk over the dunes.

Figure 24: Southern set of pedestrian access stairs at (Access P) Chalet

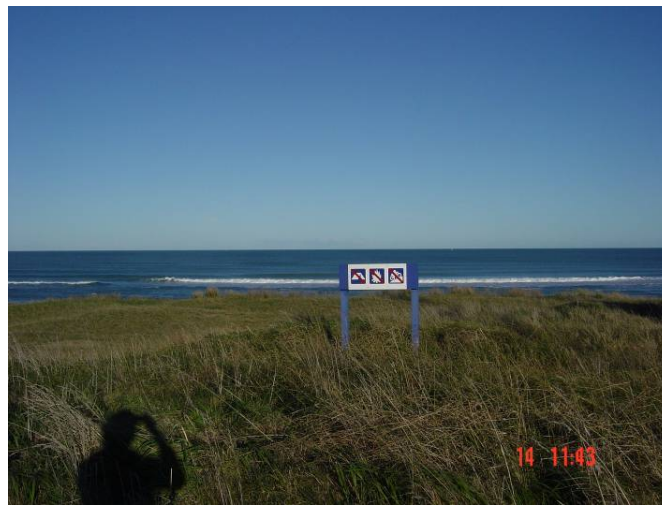
Figure 26: The sign should be removed or if still considered necessary once the area is closed off and grasses grow, then it should be replaced with a sign in keeping with other signage along the Reserves.

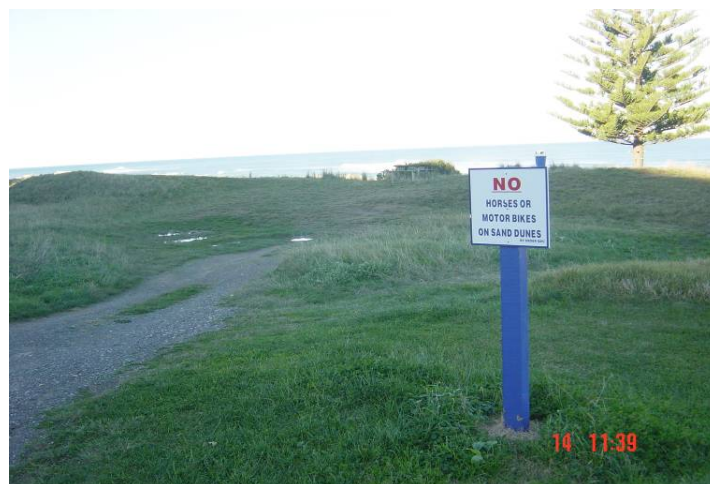
Figure 27: Sign and road entrance to Access R

This access point has one Norfolk Pine with a picnic table and rubbish bin located on the edge of the dune. It has no entrance demarcation, no formal car parking demarcation, no sand ladder/stairs

over the dunes, and the road surface and adjacent grass area conditions are muddy and pot-holed during winter months. Vehicles are accessing the dunes and driving over flat grassy areas. People predominantly use this site to view the surf, picnic, park cars or access the beach. Visitors using this site with vehicles are driving up on to the dunes, and across grass areas, to view the surf or access the dunes. There are no bollards/fencing to keep vehicles off the dunes.

This site requires appropriate car park demarcation including a hard-wearing porous road surface, perimeter fencing, and a sand ladder over the dunes.

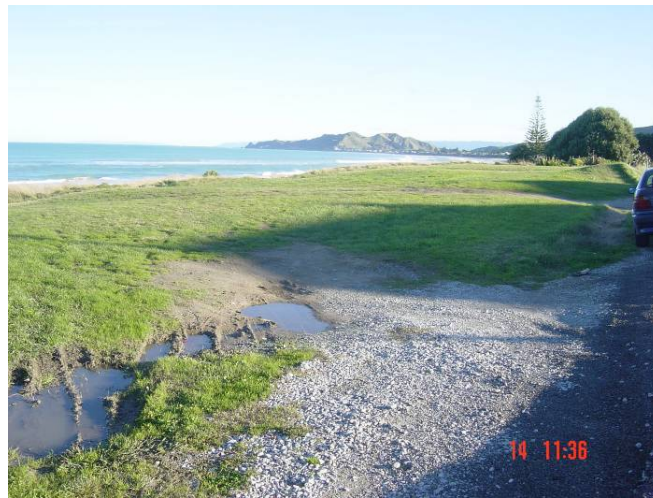
This site offers views from the road across to the beach. It is a flat grassy roadside area, easily accessible and has no car parking demarcation. The road entrance is in need of maintenance and cars park directly on the flat grass area to view the surf. Consequently, vehicles dig up the grass which becomes muddy in winter months. There are no signs or other facilities provided at this site except for one dune track which is stabilized. Pedestrians have cut many informal dune tracks through the dunes.

Figure 28: Entrance to Access S

This access requires appropriate car park demarcation, perimeter fencing with a wooden surface between bollards to provide seating, dune-care planting, a sand ladder over the dunes, and a hard-wearing porous road surface. Any flat grass area left outside of the carpark could continue to be mowed to provide a space for picnicking. If this is done, a rubbish bin will be required at the site.

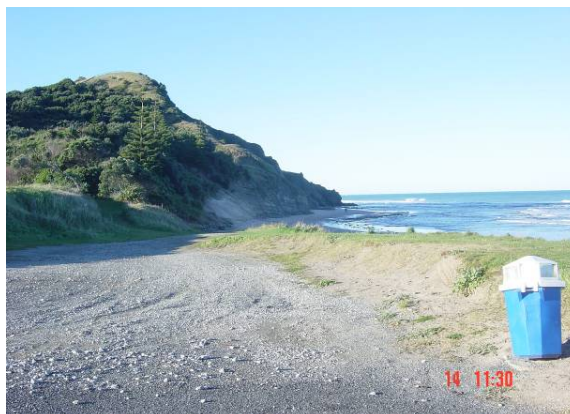
Figure 30: Rubbish Bin and vehicle access to be closed at Access T

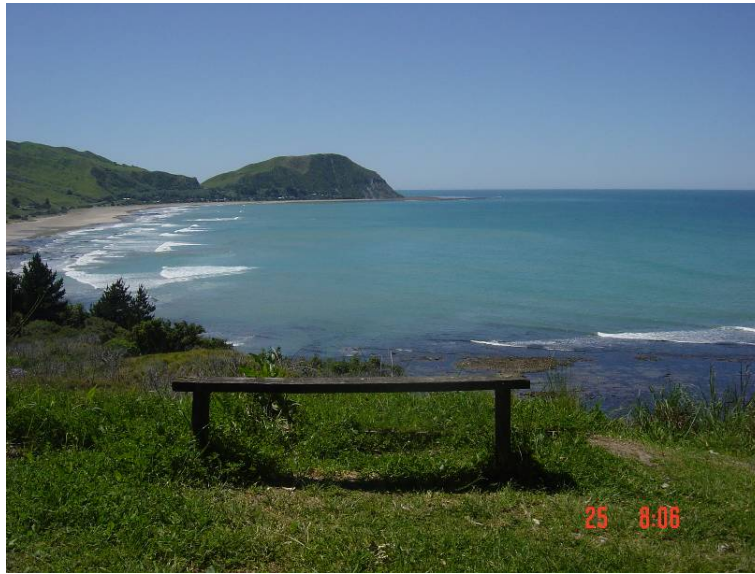
Figure 33: The views from the new northern end of the walkway with bench-seat which requires upgrading.
