## Fresh Water Resources

### Principal findings

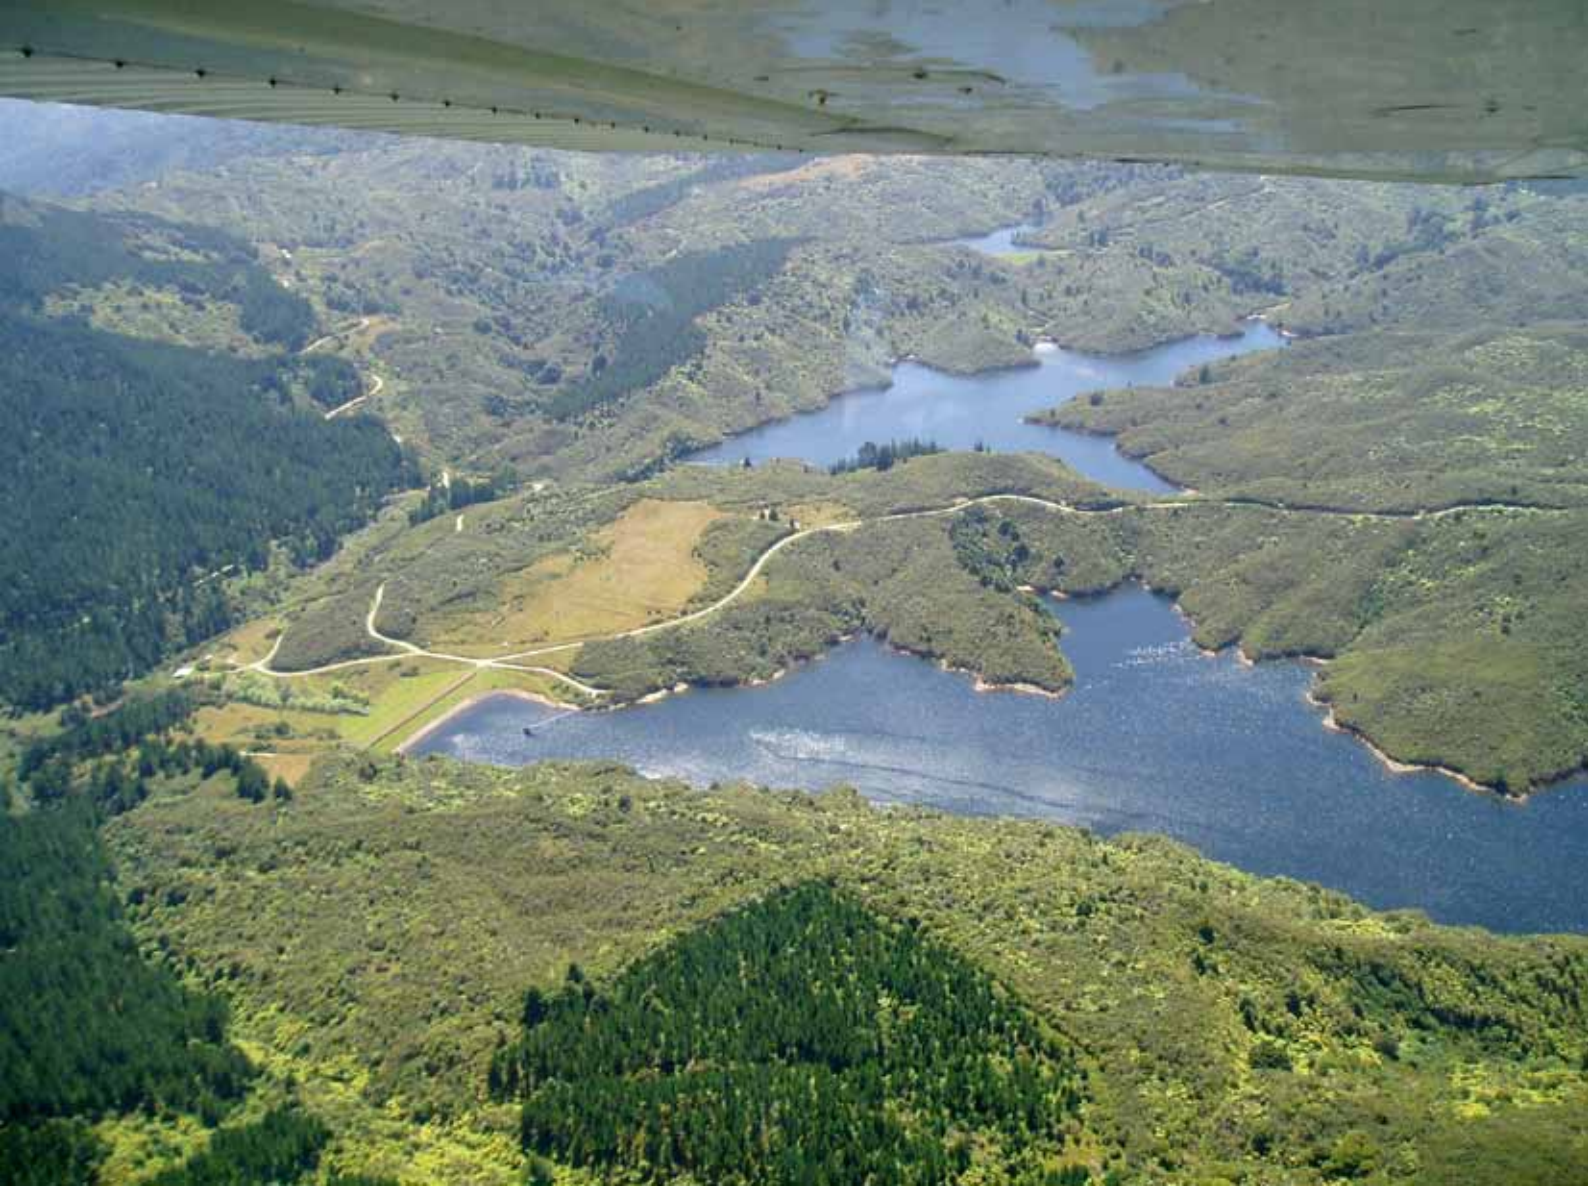
Above: Mangapoike Dams from the air.

In the 1940s the Council of the day purchased 450 hectares of land at Mangapoike and constructed 3

dams: the Sang Dam (347,568m<sup>3</sup>) that gravity feeds into the Clapcott and Williams Dams (1,121,365m<sup>3</sup> and 2,291,864m<sup>3</sup> respectively). Raw water is also sourced from the 1,100 hectare Te Arai bush catchment. Nearly all of Gisborne’s water supply is being treated at the Waingake treatment plant.

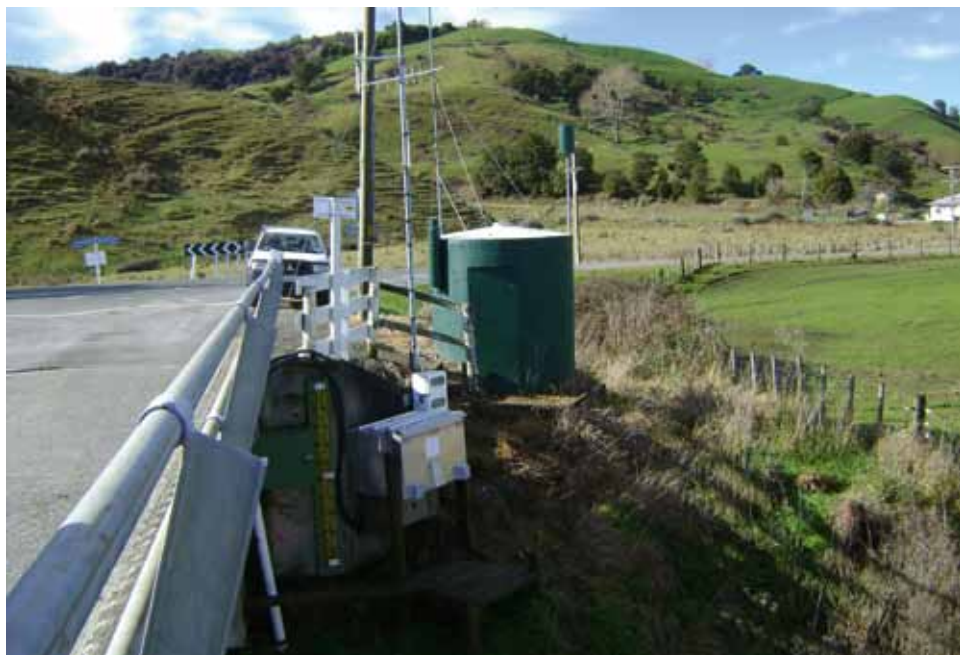
Above: Kanakanaia telemetry station, which records data on the Waipaoa River.

The job is done by forty-two automated telemetry stations, that record some or all of the following information at key locations: rainfall, water levels, water flows, temperature, wind direction, wind speed, and humidity.

The telemetry stations automatically send the data via UHF radio to the software system Hydrotel, operated by staff at the Gisborne District Council, enabling staff to view the latest values for all the telemetry stations in the District at the click of a computer mouse.

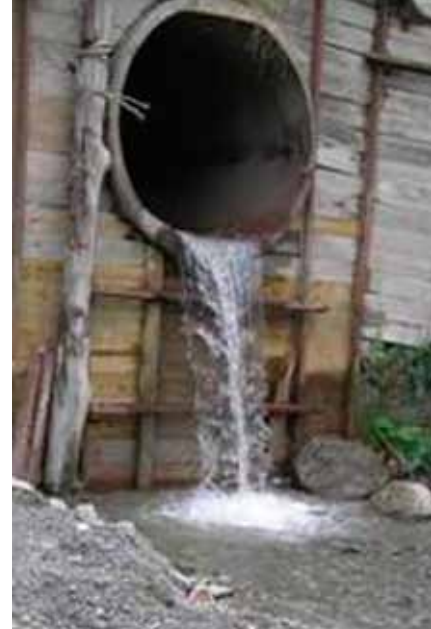
Above: Culverts with a 'drop' such as this prevent fish passage.

These tiny migrating fish are able to conquer some incredible physical obstacles, such as rapids, natural waterfalls, and even land for short distances. However many fish need low-speed zones and wetted margins at the water's edge which climbing species can traverse. Just a single, impassable man-made barrier in their path, debris build up around structures and floodgates, concentrated too-fast water, thinly-spread too-

shallow water, or a culvert that's too long and dark, can prevent fish from completing their lifecycles leading to catastrophic decline in fish populations.

It is a legal requirement for structures placed in waterways after 1984 to allow for fish passage. Guidelines are available from both the Gisborne District Council and DoC. The Biodiversity Condition and Advice Fund may be available to assist private landowners wishing to enhance fish passage on private property. Criteria are available at [www.biodiversity.govt.nz](http://www.biodiversity.govt.nz)
