ANNEX 1 ► Site Descriptions (access A-U) and Management Recommendations

ACCESS A – U

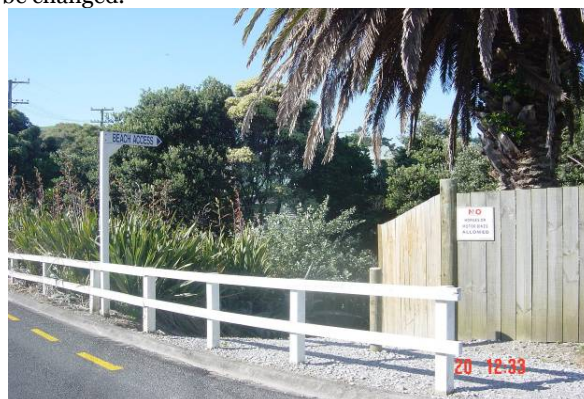
Figure 10: Suggested horse access to Wainui Beach.

This access is well-presented from the road, with a metal chip surface in good condition. A sign is present saying 'No motorbikes or horses allowed by Order of GDC'. The track is wide and light and offers a tranquil stream-side experience as users walk down the side of Hamanatua Stream. The riverbank is planted with a mix of indigenous and introduced species, which should be further planted with stabilizing indigenous riparian species. Neighbors' are encroaching onto the reserve land with their gardens. Despite this, there is a clear flat path to the beach with a narrow set of stairs leading onto the edge of the stream outflow area. This access should become a horse only access to enable safe passage for horses from the near-by residential area. Pedestrians can of course use the accessway, but it will mean they should be aware they may meet a horse and rider. The sign should be changed.

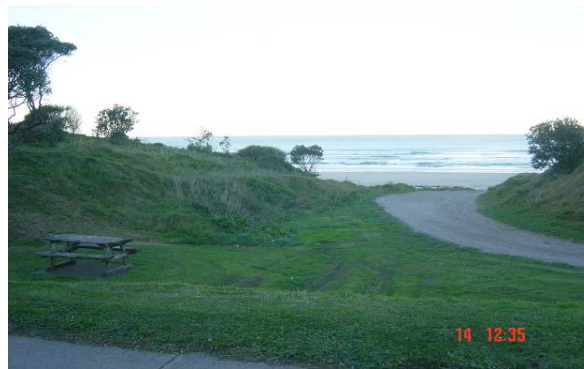
Figure 16: Access H (Schools)

One management issue noted by several parties is that people are using the bushes north and south of the beachfront car park as a toilet. A sign is needed which notes the nearest public toilets.

The original proposal to seal and expand Access H (Schools) has been adapted to contain vehicles at the roadside and provide a formal carpark area (to contain 8-10 cars, 6m deep) with a pedestrian walkway over the northern section, down to the reserve and onto the beach. The softscaping changes, such as a ponding area and planting of indigenous wetland species, are shown on the landscape plans in Annex 5 and within the Management Plan's text. Wide shallow steps are proposed to provide access to the beach and to assist gradual stormwater run off to the beach.

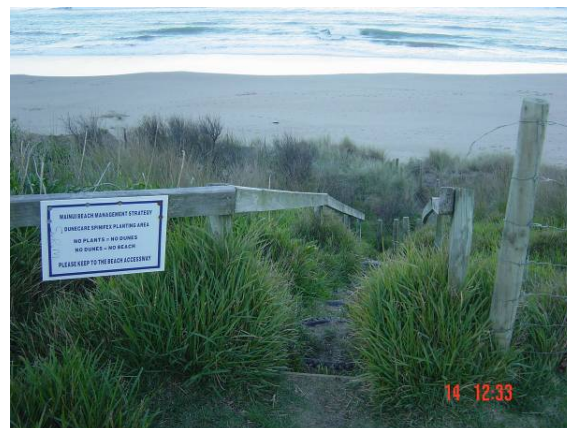
Figure 17: Access I stairs over foredune, through the dunecare programme and down to Wainui Beach

This site offers beach access via a staircase, is predominantly a flat grassy area with no beach views until on the fringe of the dunes, and has a picnic table and rubbish bin not near the view. A sign is needed which notes the nearest public toilets and permitted activities. The rubbish bin and picnic table should be moved to offer views of the beach. The stairs need upgrading, and the perimeter fencing along the road-front should be upgraded and constructed of organic materials consistent with materials used in other parts of the Reserve.

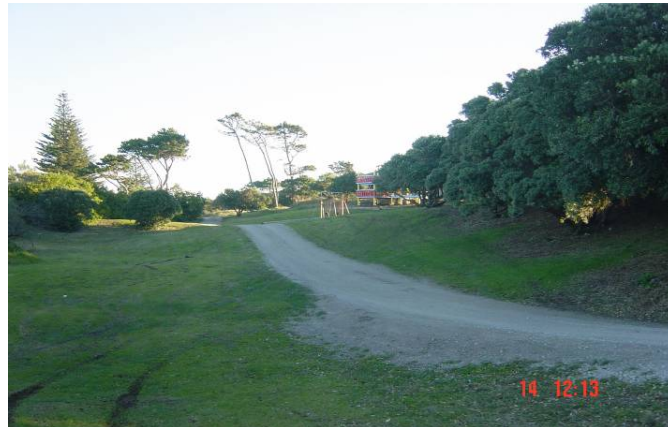
Figure 19: Current metal road joining Access L and M

A short metal chip road joins Pines access L to Okitu Store Access M. To ensure the safety of children and families using the playground areas, as well as further reduce Council's maintenance costs, this road should be closed to vehicle access and turned into a pedestrian walkway. Along this road, and within short walking distance, are two children's playgrounds. The first children's playground consists of two swings and two seesaws. There is a picnic table at this site and no rubbish bin. A rubbish bin is recommended. The picnic table should be shifted for better coastal views, and complemented with planting for shade, as indicated in the landscape plans in Annex 2. The rubbish bin should be placed near it. This playground is in fair condition and not maintained to the standard of the second, and larger playground.

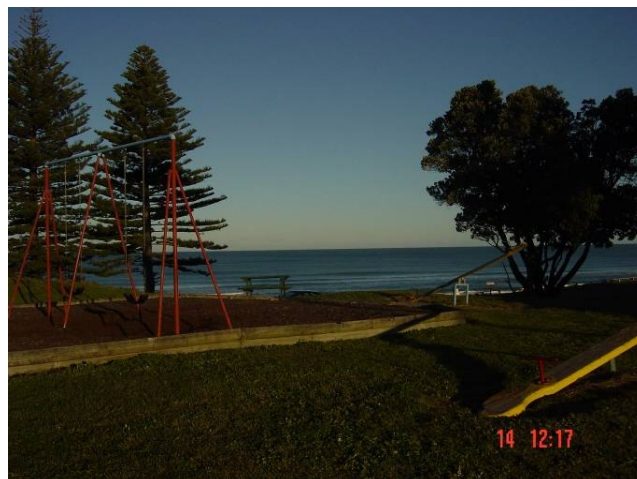
Figure 20: The Children's Playground at Pines
(to be amalgamated with the larger Children's Playground further north)

Both playgrounds are painted in bright colours (blue, red and yellow). These facilities do not enhance natural coastal values of the Reserve. The playgrounds were assessed in 2006 and are scheduled for upgrading after the Management Plan is approved. New play equipment will be provided and the play ground area will shift away from the large pohutukawa trees towards the coast, and closer to Access M car park.

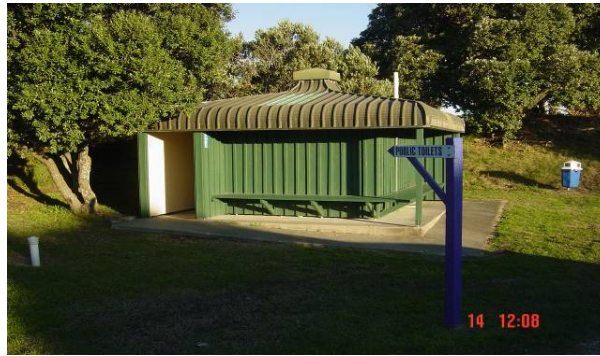
Figure 21: Public Toilets along State Highway 35

The public toilets and rubbish bin located north of this car access point, on State Highway 35, are in good condition and should continue to be maintained. During peak summer months they require a more intensive maintenance regime.

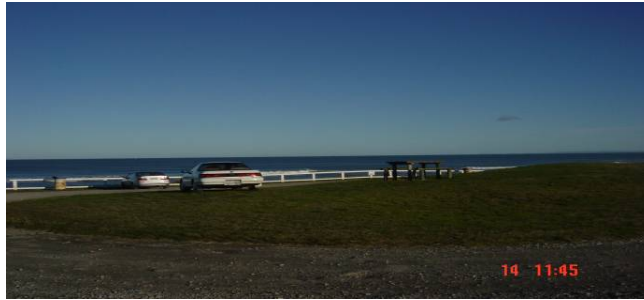
Figure 23: Chalet carpark from the northern entrance

The large flat open area commonly know as ‘The Chalet’ is a great asset to W. D. Lysnar Reserve and receives a large number of visitors throughout the year. This site should be kept as an open space with horse and pedestrian access from the car park. The entrance has one sign at the southern road entrance. It should also have another sign located at the northern access for vehicles traveling into Gisborne from the East Cape. Other smaller signs at the site should be removed.

The middle access road should be removed (see Annex 2).

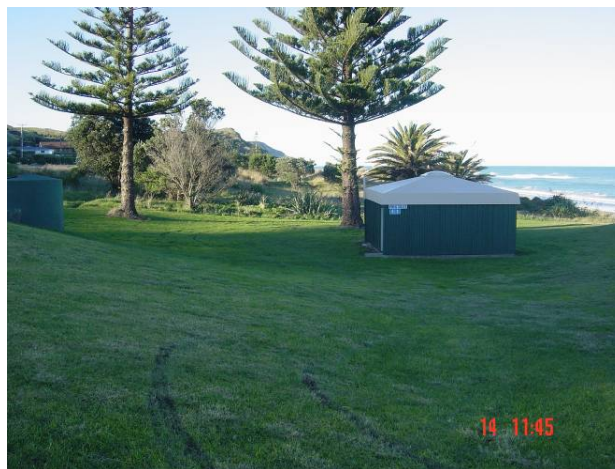
Figure 25: The public toilet from the entrance road.

The public toilet located at Chalet is in a good location and in good condition. Better signage denoting that the structure is a public toilet is recommended and a pedestrian access track should be developed to link it to the road and carparking.

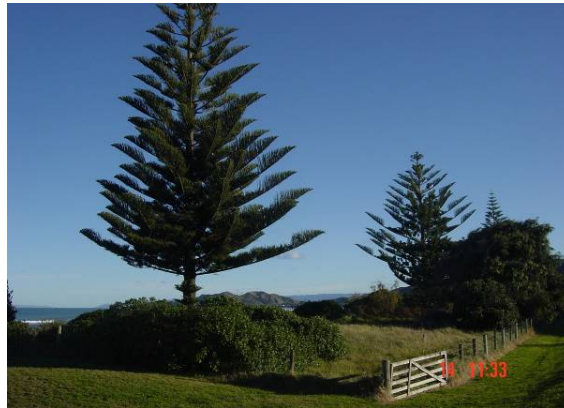
Figure 29: Whales Grave

whales. It is a site of interest for visitors to the area and sign-posted and the area fenced. Planting is a mix of exotics and indigenous plants. In the future, indigenous plants should be planted, such as karo, flax and cabbage trees, and exotics removed. The fence around the site should be upgraded. Car parking for the site will be encouraged at the northern most point of the beach which has good vehicle access and public toilets. A pedestrian track, with a small sign noting the Whales Grave, should be located at the carpark. The track will lead to a viewing area with a larger interpretive sign and sculpture. The viewing area should be located on the beach-side of the northern-most corner of the gravesite.

Cars are accessing the dunes at the northern end of the graves site. The perimeter fencing running the length of the Reserve will mitigate this problem.

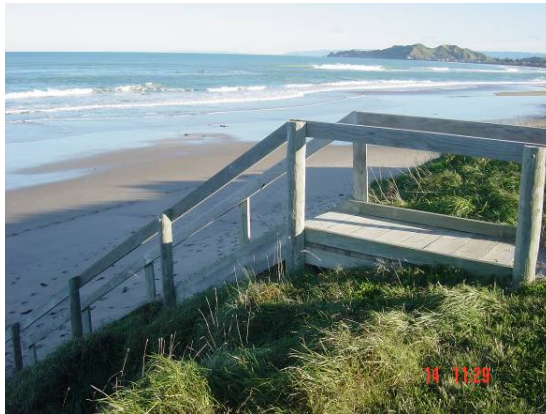
Figure 31: Stairs over the dunes and down to the beach at Access T

There are two rubbish bins and one set of stairs to the beach in good condition.

Some bollards have been placed on the southern side of the car park, along the road-side front of the public toilet. These should be used as the northernmost point of the perimeter fencing for Lysnar Reserve. Bollards should also close off the boat ramp to the beach as this site will no longer provide vehicle access to the beach.

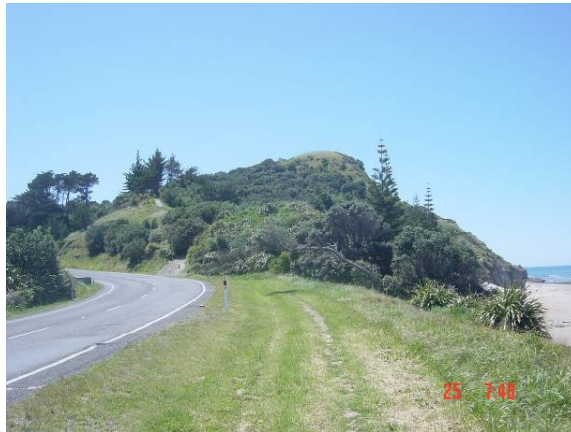
Figure 32: The start of the Makorori Headland walkway.

In order to begin to address the issue of inconsistent facilities and vegetation between the two reserves, Council recently (April 2007) began upgrading access on the Headland. Tracks have been widened and extended and stairs upgraded. An additional vantage point with picnic seating has been provided half-way up the track. At the top of the Headland, the current picnic seating is in fairly good condition. The single bench-seat should be removed and another picnic table placed at this location (on a level surface). Further, the perimeter fencing around the cliff-top should be upgraded using materials that least impede the view. Upgraded signage at the bottom of the track showing routes, seating, and view vantage points is needed. The sign should also advise visitors to take rubbish with them. No rubbish bins should be placed on the Headland. No signs should be located on the top of the headland in order to retain the uninterrupted and sweeping views.

A new track on Makorori Headland, starting opposite the Okitu Bush carpark and linking to the existing track, should be developed to increase the recreation flow between the two reserves and improve public safety. This track should not be developed until the necessary safety precautions can be made with Transit New Zealand to erect safety barriers and reduce the speed limit to 80 km/h.
