# the state of our environment

Published by Gisborne District Council

Gisborne 2007 and 2008

## The Coast

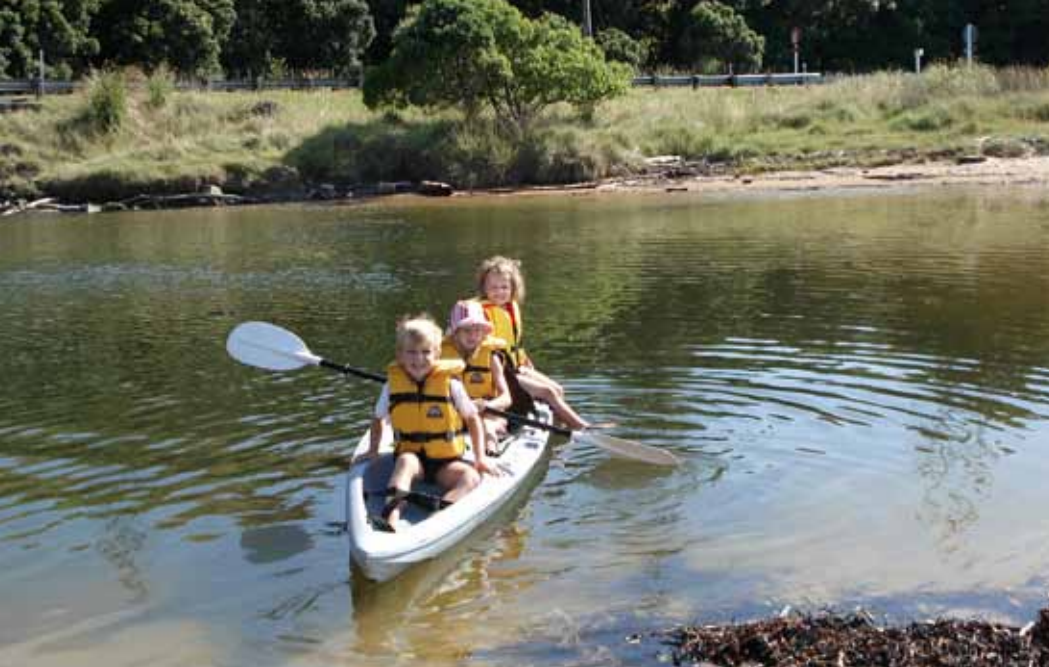
**Above: Turihaua Lagoon is a popular spot with families, but can have high bacteria counts.**

In 2007-2008 four results that were not explained by high rainfall came from Turihaua Beach, Wainui Beach opposite the Surf Club, Waikanae Beach opposite the Surf Club and Midway Beach opposite the Surf Club.

Nine exceedences during the summer of 2008/2009 were not explained by high rainfall. These sites were Turihaua Beach, Waikanae Beach opposite the Surf Club Makarori Beach opposite the settlement, Tolaga Bay Beach at the end of Wharf Road, Anaura Bay Beach opposite the south camp and Midway Beach opposite the Surf Club.

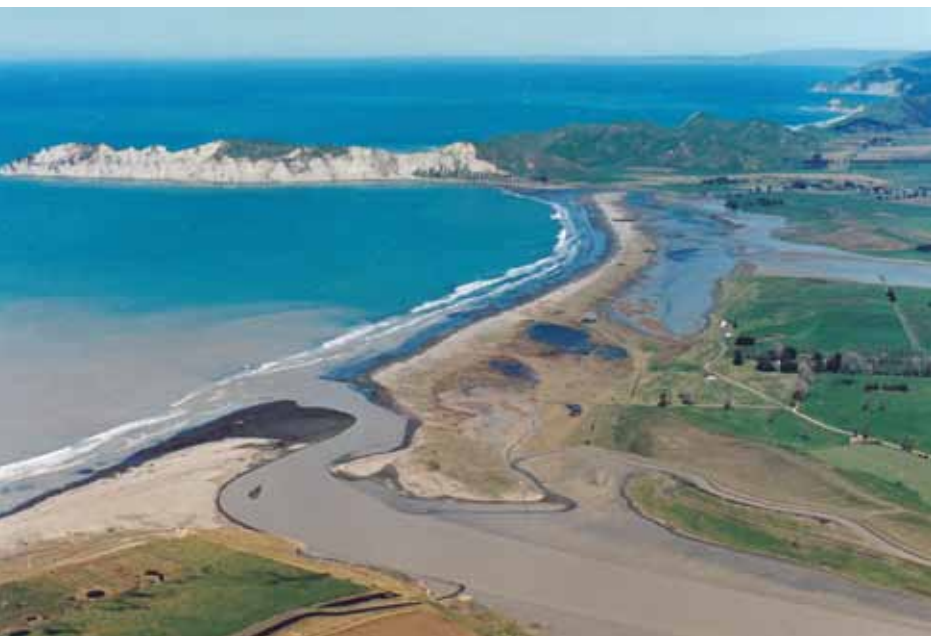
Above: The Waipaoa River in flood discharges a plume of muddy water into Poverty Bay. (Photo: Dave Peacock, Gisborne District Council)

The Waipaoa River is region's second ranking river in terms of suspended sediment discharge, delivering fifteen million tonnes of mud, silt and sand per year to coastal Poverty Bay. That's the equivalent of about 4,100 truckloads per day.

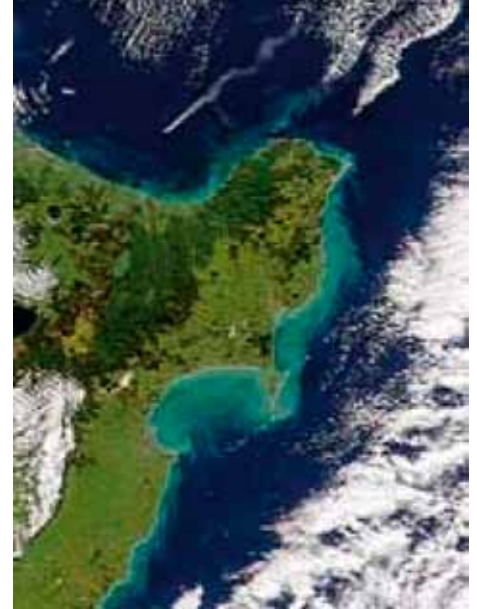
Above: Detail from a Seawifs satellite image from 11 May 1999 showing sediment plumes around the East Coast following rainfall centred on Mahia peninsula. (Image: Seawifs, NASA)

Several rivers carrying high suspended-sediment loads (extremely high during floods), discharge to the open sea along the East Coast. Suspended sediment plumes contain a mixture of particle sizes and with them transport bacteria, nutrients and possibly chemical contaminants into the ocean.
